Revised
FULL RESERVE STUDY
2615 Park
Avenue Associates

Minneapolis, Minnesota
Inspected - August 12, 2020
Revised - December 1, 2020

2615 Park Avenue Associates
Minneapolis, Minnesota

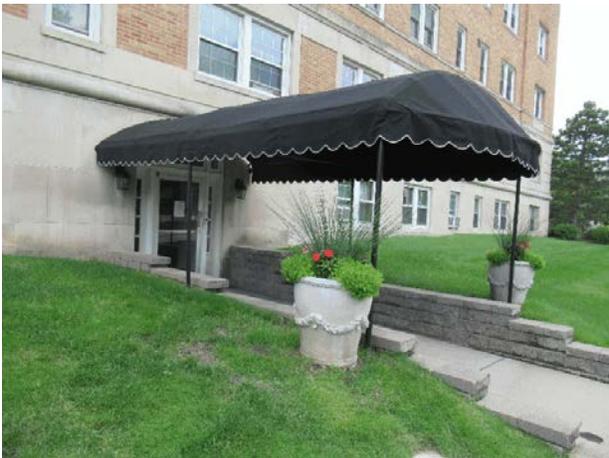
Condition: Fair overall with minor fade of the fabric and minor frame corrosion evident.

Overview of awning at north elevation

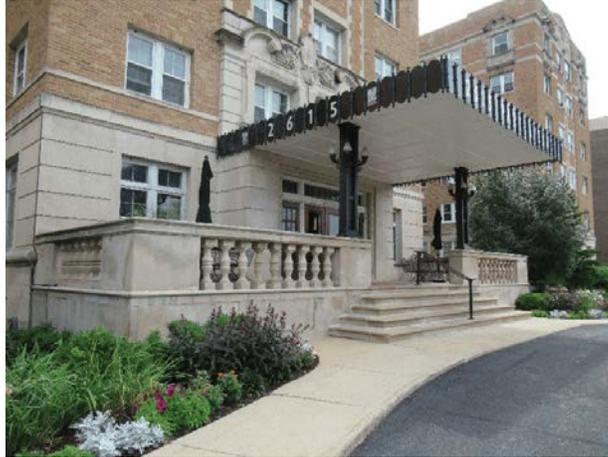
Condition: Good overall condition

Canopy overview

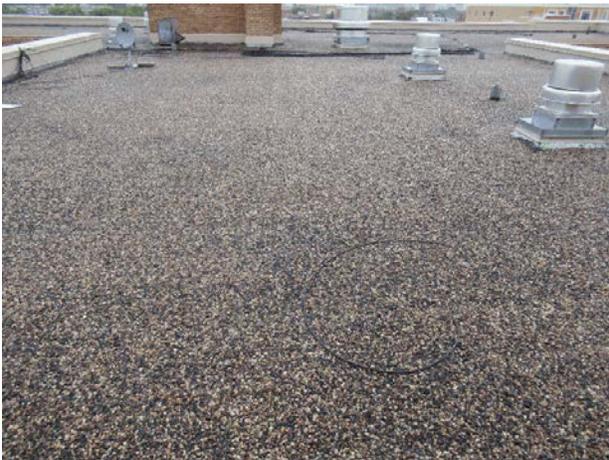
Condition: Visually the built-up roof is in fair overall condition. We note finish deterioration at the parapet walls, standing water, finish deterioration and damage to drain and vent components, blistering, prior repairs and coating deterioration evident. Management and the Board do not inform us of a history of known leaks. The roof was last inspected in 2018.

Overview of built-up roof

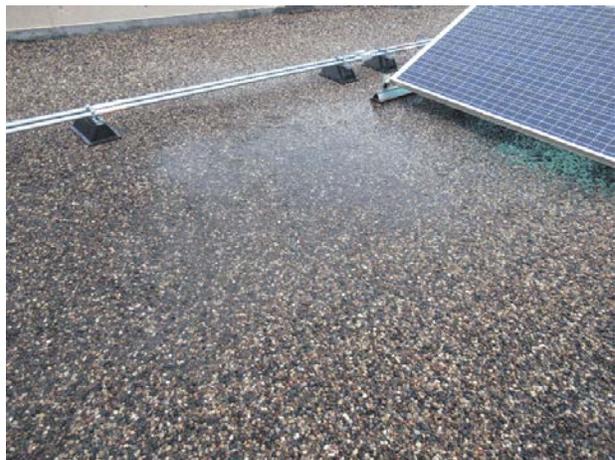
Standing water

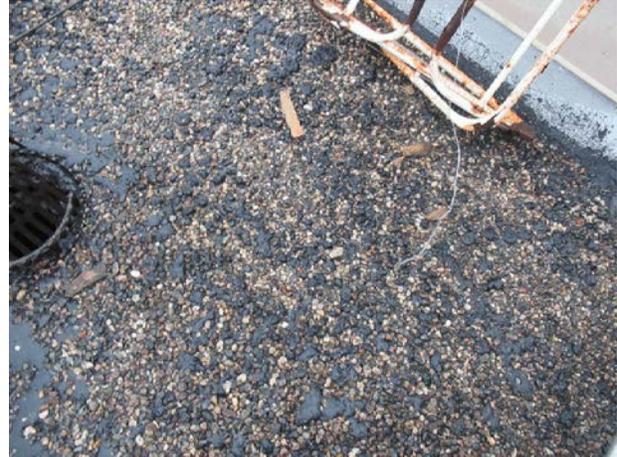
Blistering – condition is a result of the expansion of air beneath the bituminous

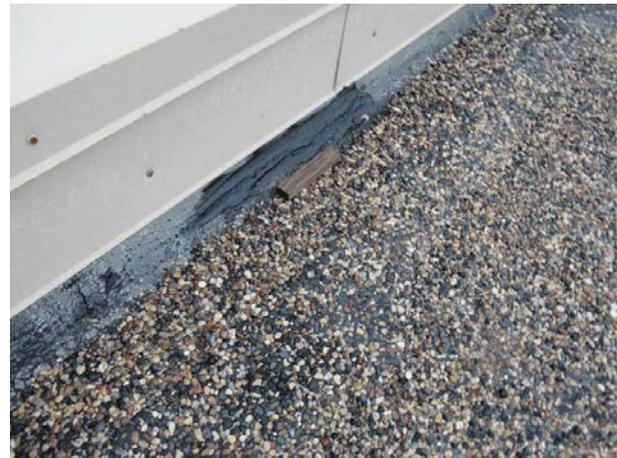
Prior repairs

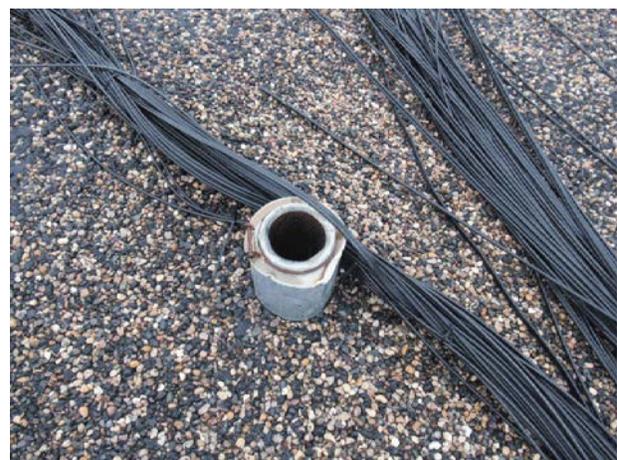
Minor vent damage

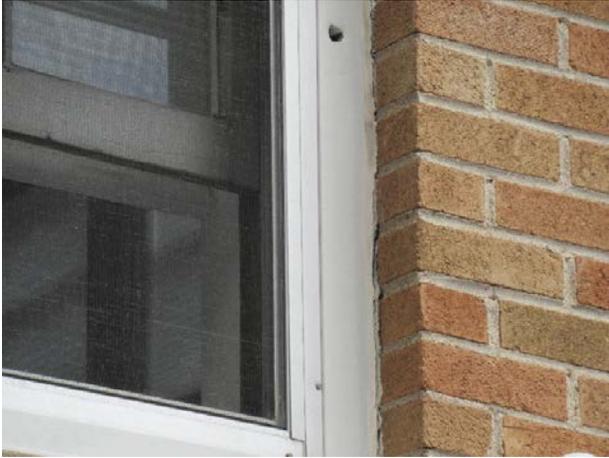
Condition: Fair to poor overall with missing sealants, sealant deterioration and isolated repairs evident.

Window sealant deterioration

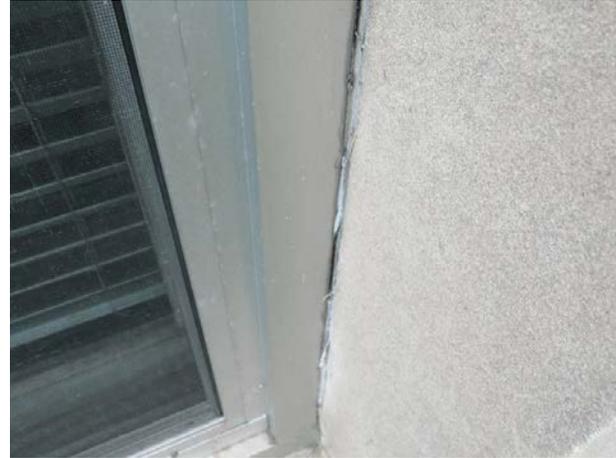
Missing sealants

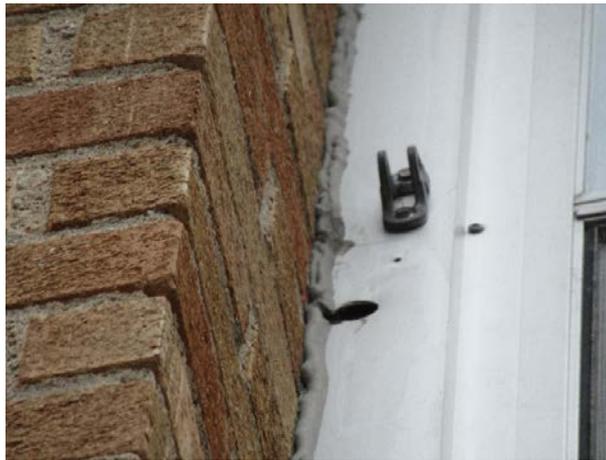
Frame damage with prior sealant repair

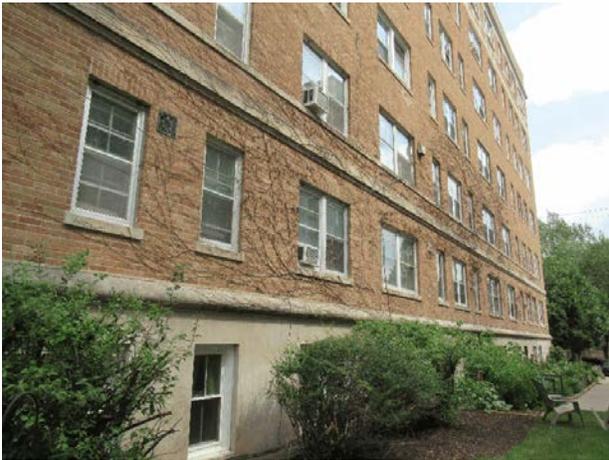
- Extensive previous repairs evident
- Efflorescence is not visible
- Lintels exhibit rust
- Masonry exhibits cracks
- Masonry exhibits spalls
- Mortar deterioration is evident
- Mortar joints are tooled

Overview of masonry with organic growth evident

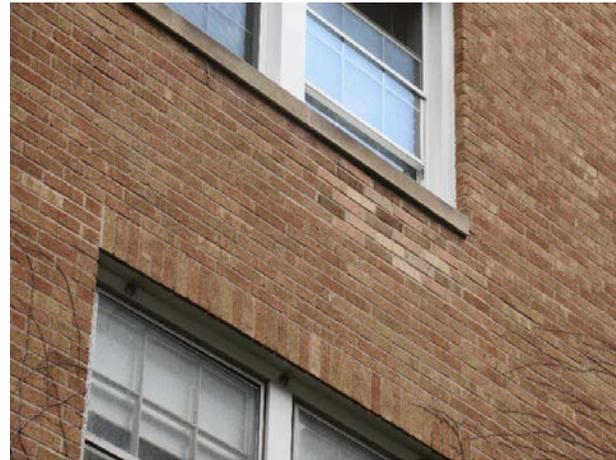
Prior masonry repairs

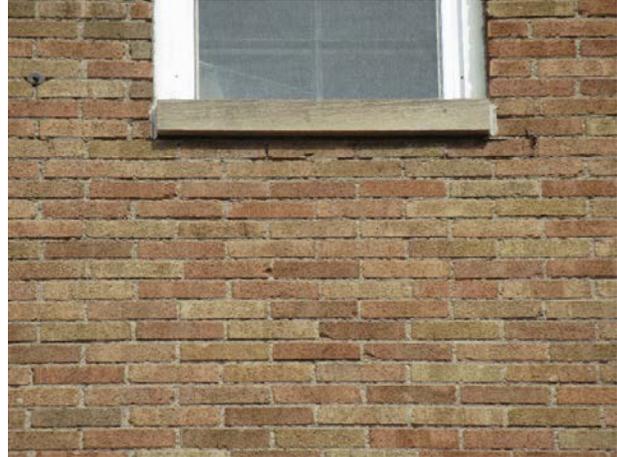
Mortar deterioration

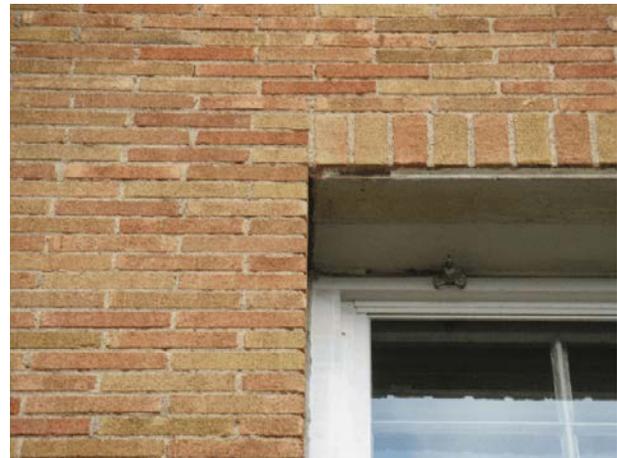
Mortar deterioration above lintel

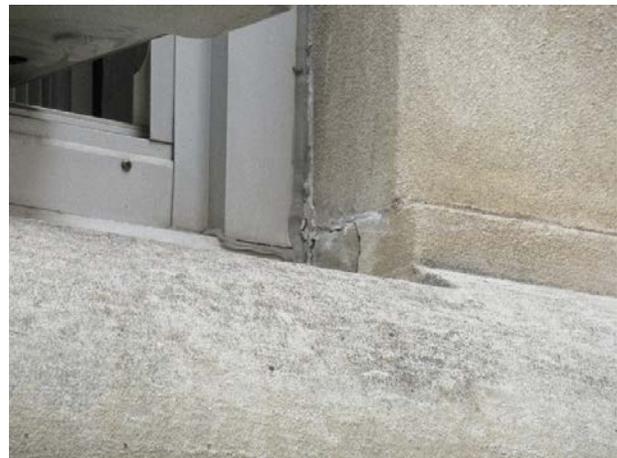
Crack at prior concrete repair

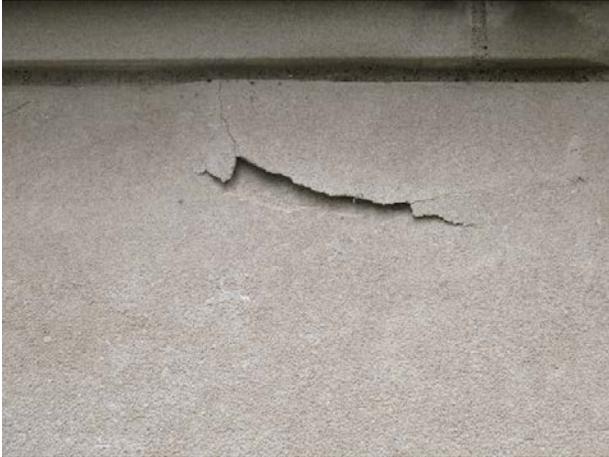
Spalled concrete

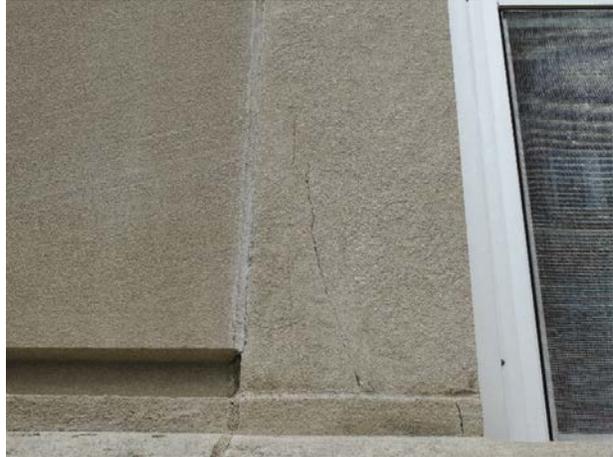
Concrete crack

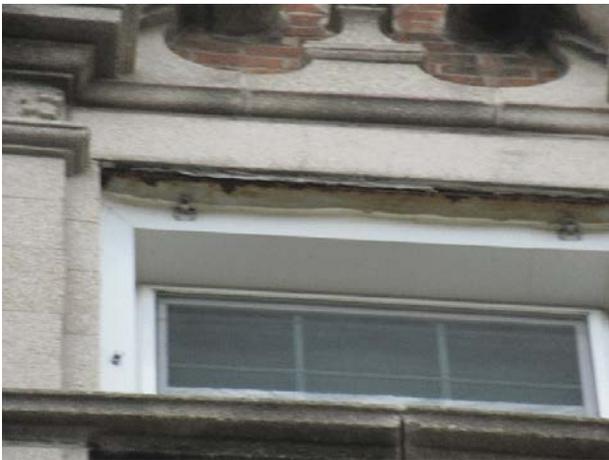
Lintel with significant corrosion

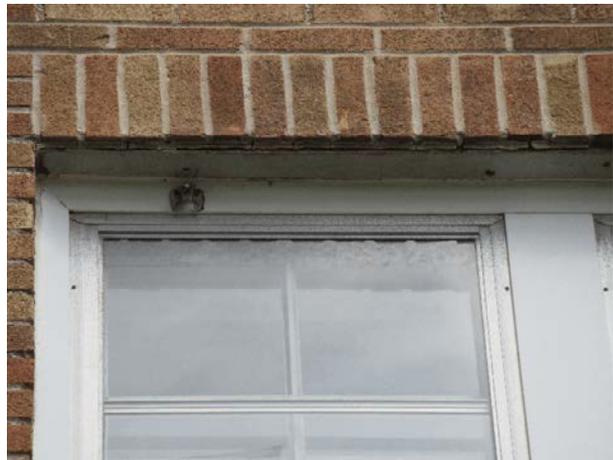
Lintel corrosion

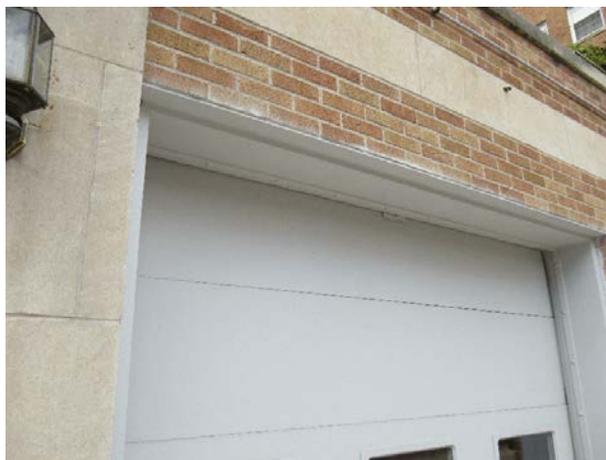
Garage lintels in good condition

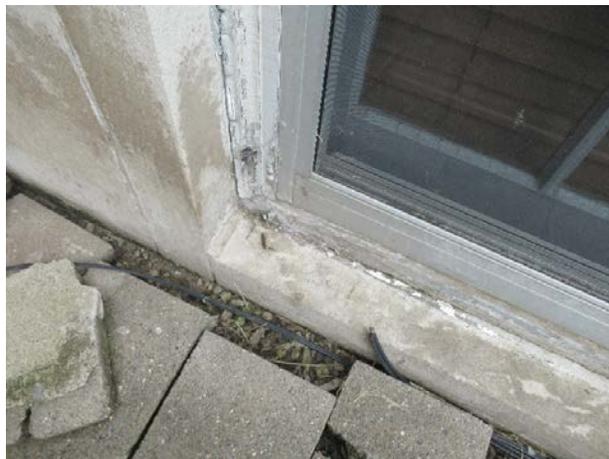
Condition: Fair overall with isolated deterioration of frames evident

Frame deterioration

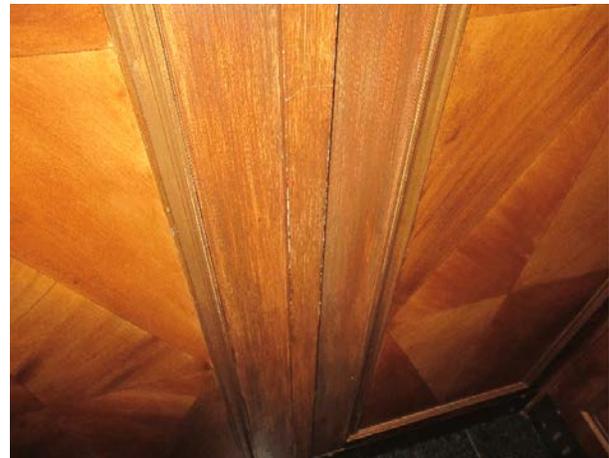
Wood walls with finish deterioration

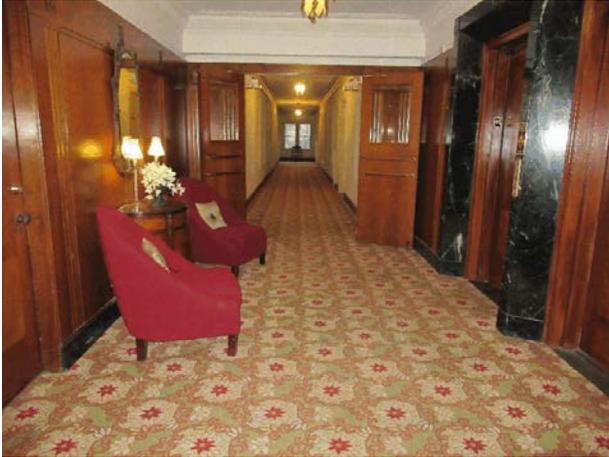
Condition: Good to fair overall with stains evident

Carpet overview

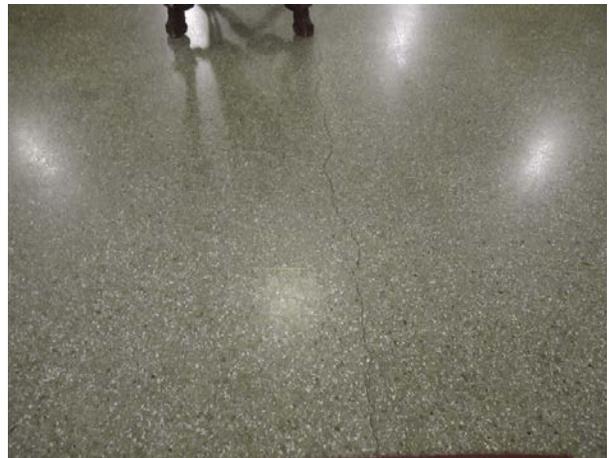
Terrazzo floor crack

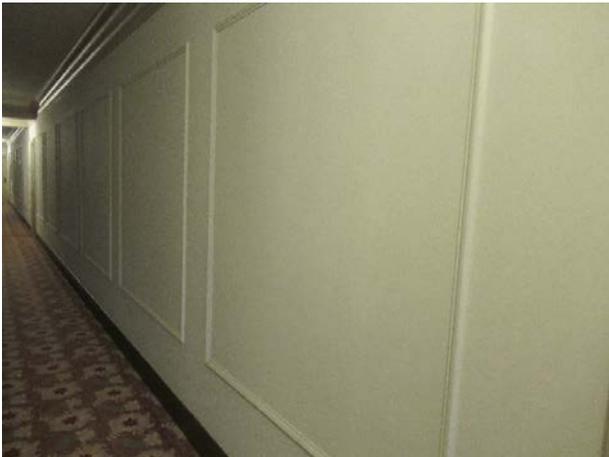
Condition: The paint finishes at the hallways are in good to fair overall condition with scuffs and paint peel evident. The paint finishes at the shareholders doors are in fair to poor overall condition with paint damage evident. The paint finishes at the stairwells is in good to fair overall condition with isolated wall cracks and scuffs evident.

Hallway paint

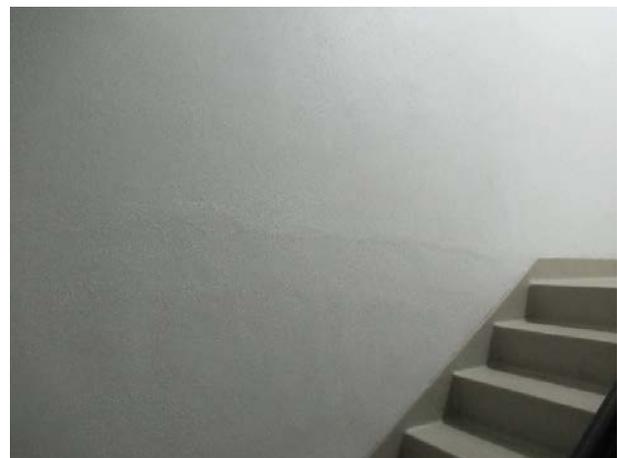
Wall crack

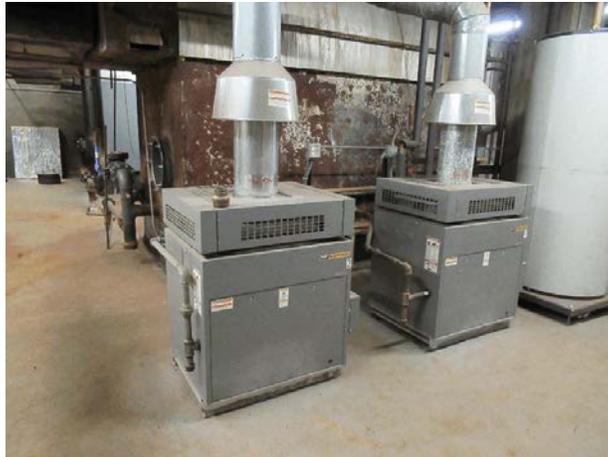
Condition: Management and the Board inform us the condensate return pump is currently failing. Refer to our narrative "**Pumps**" for replacement of the condensate return pump.

Boiler

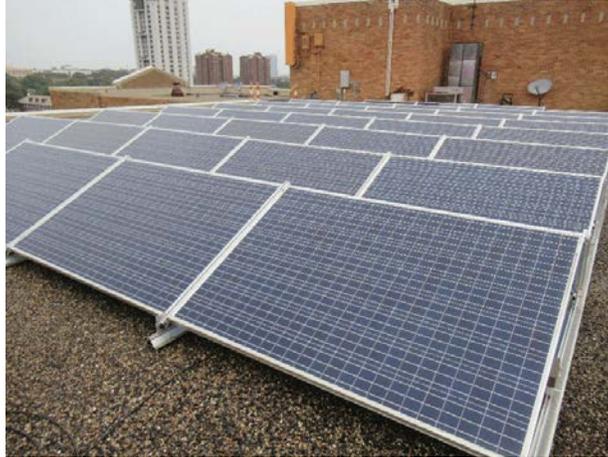
Condition: Reported in satisfactory operational condition. The reported gains from the system are insufficient.

Solar panels

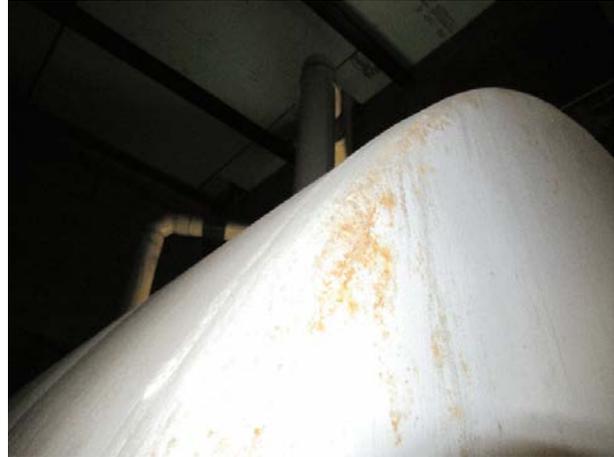
Minor surface corrosion

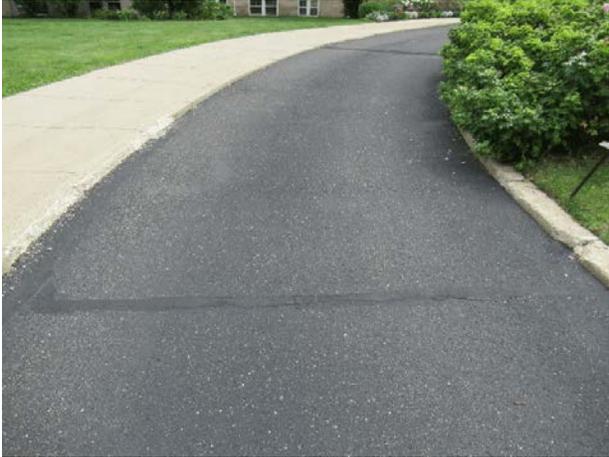
Condition: The pavement is in fair overall condition with transverse cracks, prior crack repairs and seal coat deterioration evident.

Asphalt pavement access drive overview

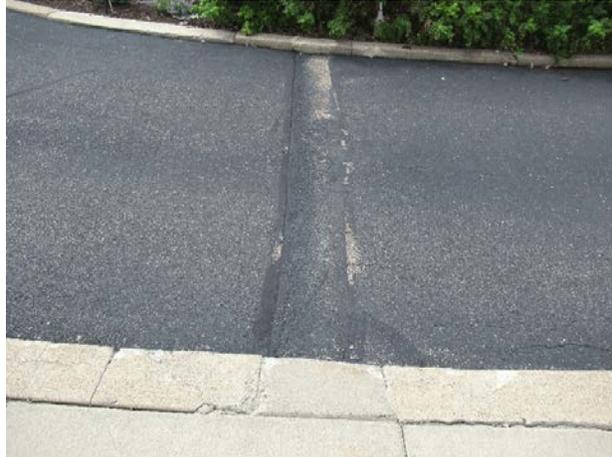
Transverse cracks with prior repairs

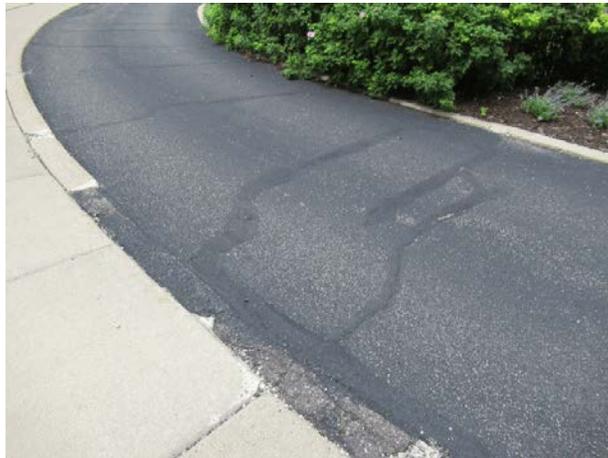
Transverse cracks with prior repairs

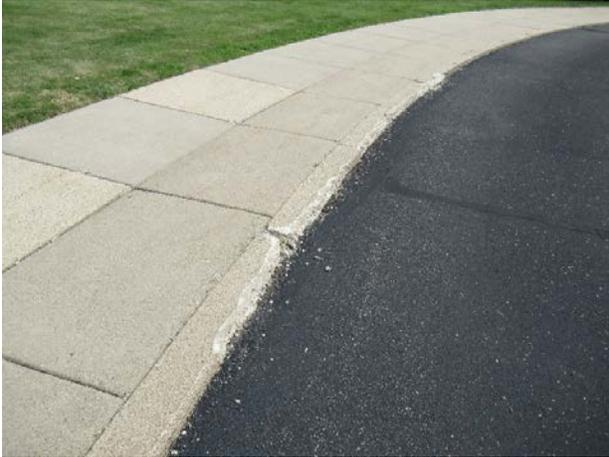
Condition: Fair overall with concrete deterioration evident

Curb overview with concrete deterioration

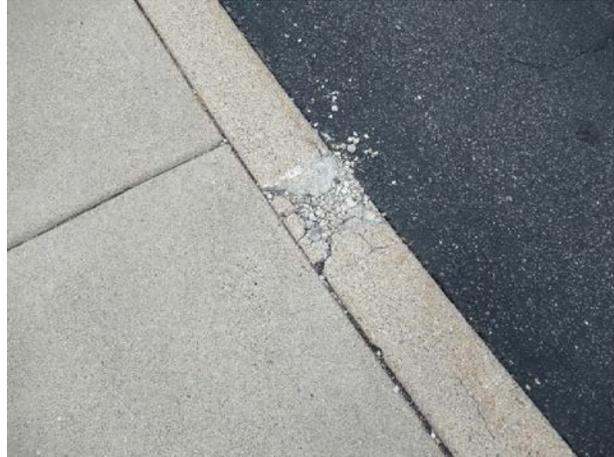
Concrete curb deterioration

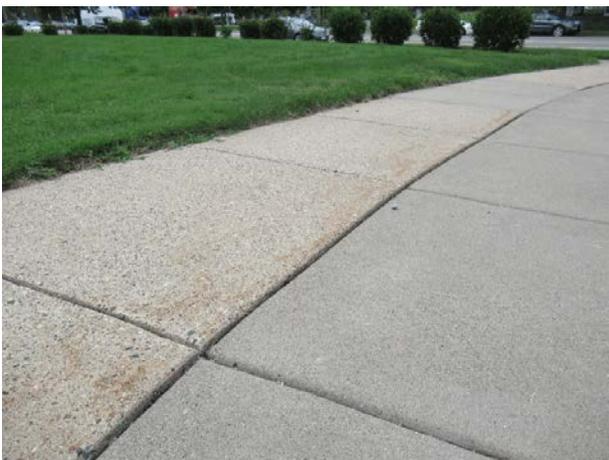
Condition: Good to fair overall with surface pitting and prior partial replacements evident

Sidewalk overview with surface pitting

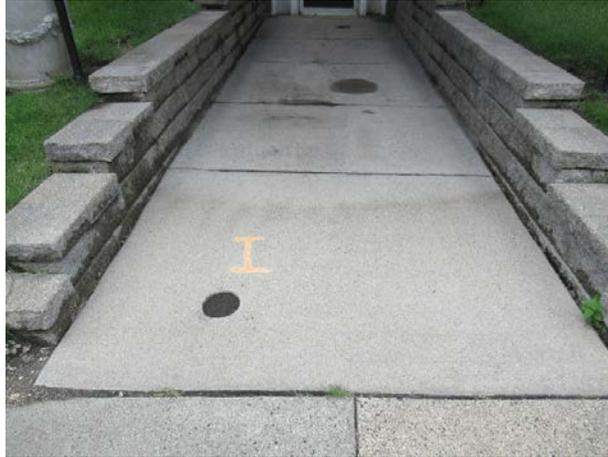
Prior replacement

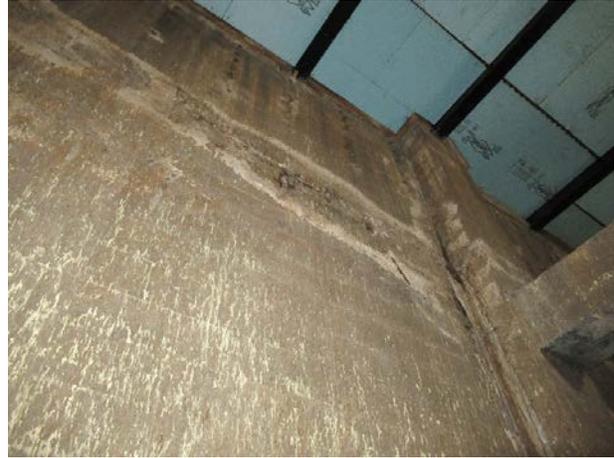
Prior water stains

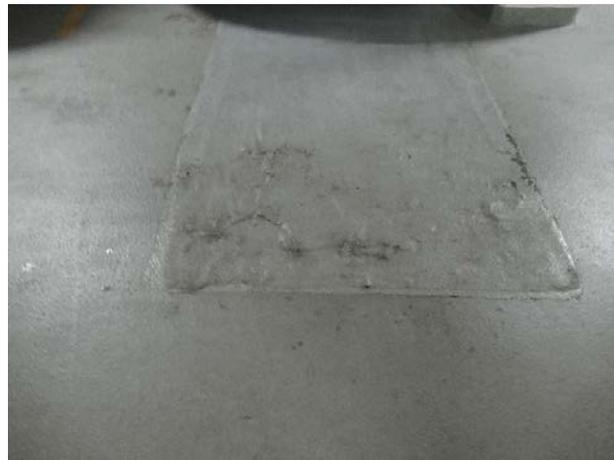
Condition and History: Good to fair overall with prior repairs and concrete deterioration evident. The elevated structural concrete does utilize a protective traffic coating.

Prior repair

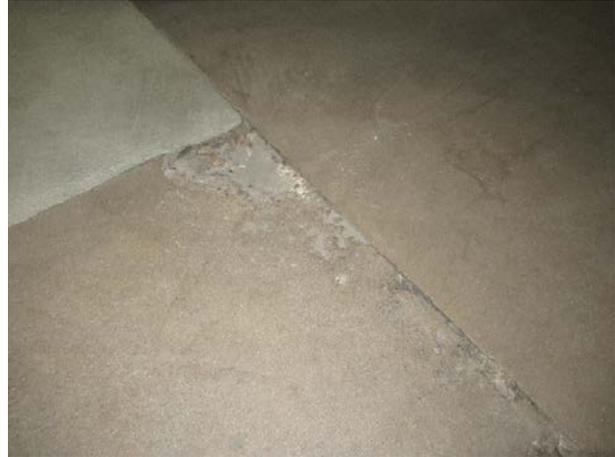
Condition: Fair overall with cracks, concrete deterioration, surface pitting and prior repairs evident. The Cooperative was in the process of adding a sealant to the perimeter walls and performing on-grade floor and column repairs at the time of our inspection.

Concrete spalling

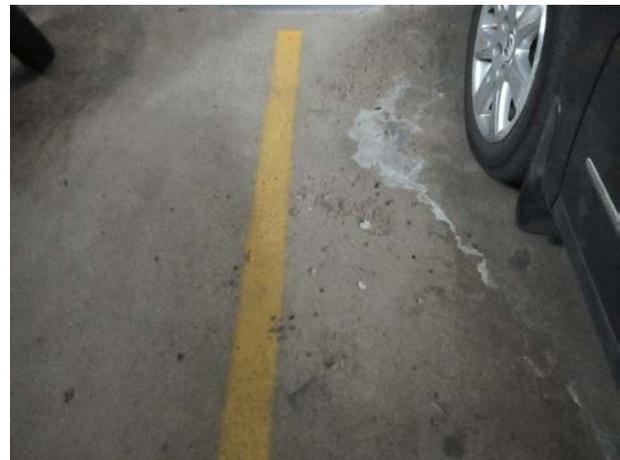
Surface pitting

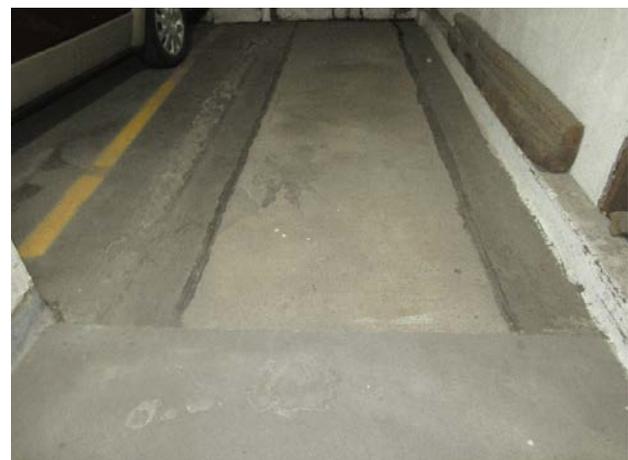
Prior slab repair

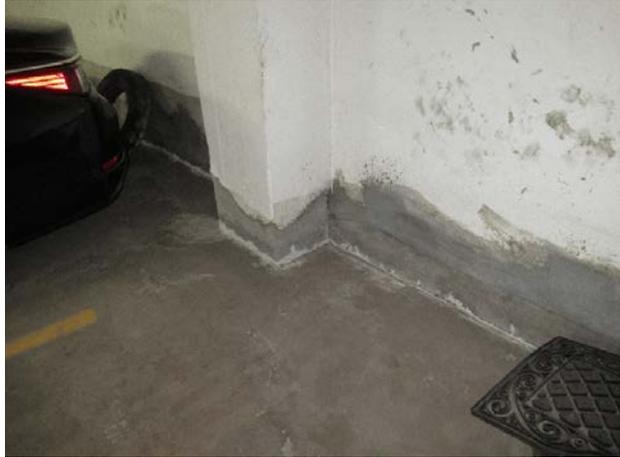
Prior wall repairs
