Revised
FULL RESERVE STUDY
2615 Park
Avenue Associates

Minneapolis, Minnesota
Inspected - August 12, 2020
Revised - December 1, 2020

2615 Park Avenue Associates
Minneapolis, Minnesota

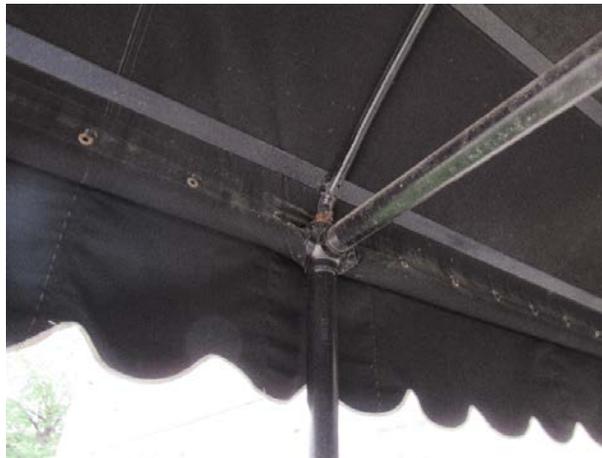
Minor frame corrosion

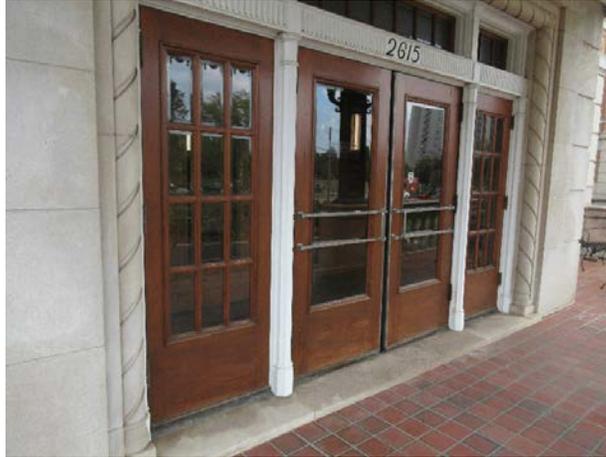
Entrance doors

Condition: Fair overall with stain finish deterioration evident

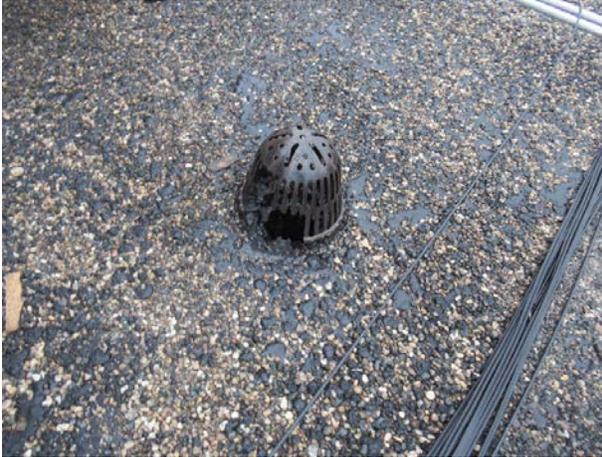
Damage of roof drain

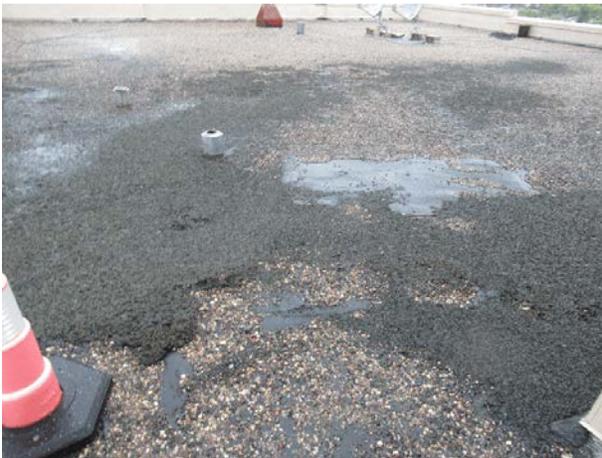
Prior repairs

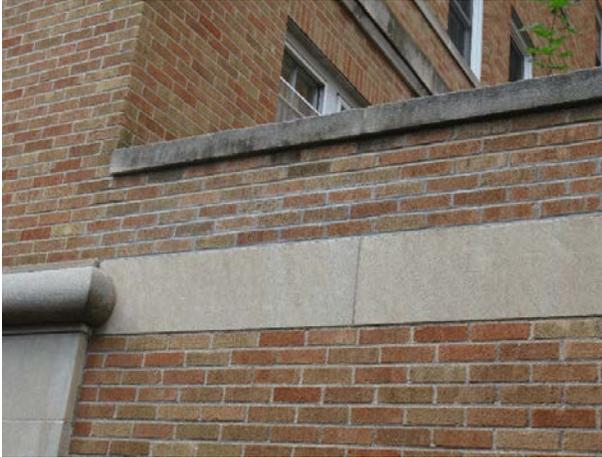
Prior masonry repairs

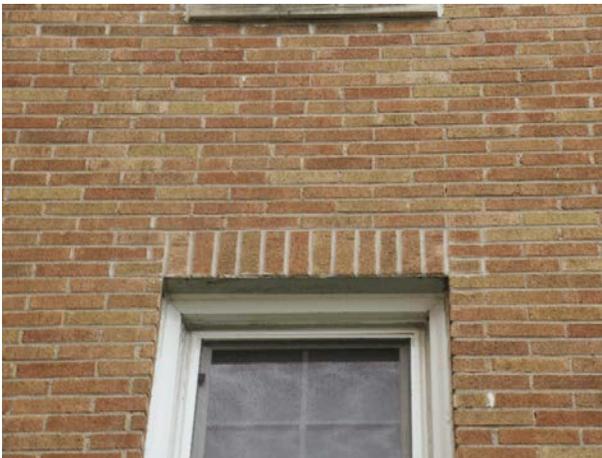
Prior repairs above lintel

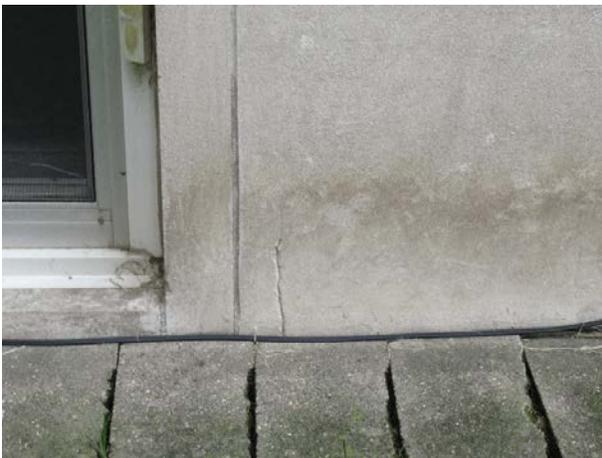
Concrete crack

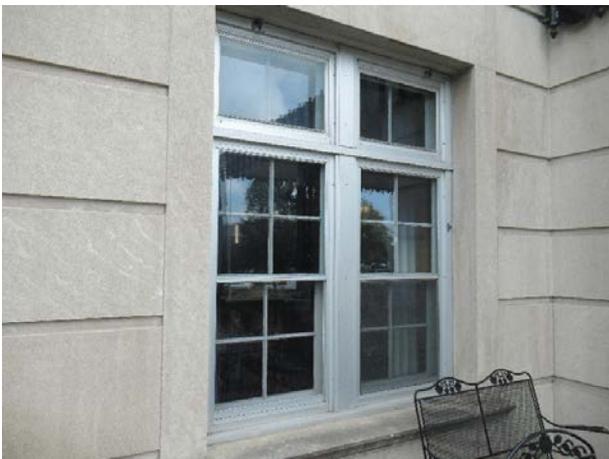
Window overview

Condition: Fair overall with isolated deterioration of frames evident

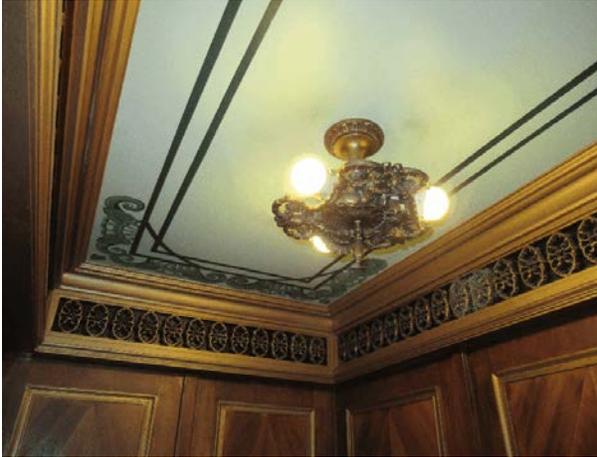
Condition: Good to fair overall with stain deterioration on the wood walls

Wood and glass ceiling finishes

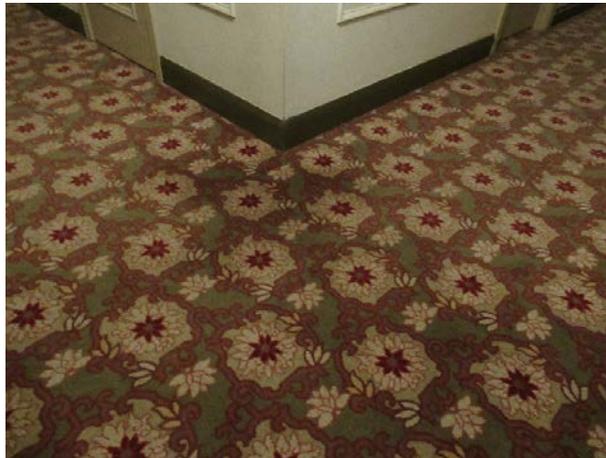
Carpet stains

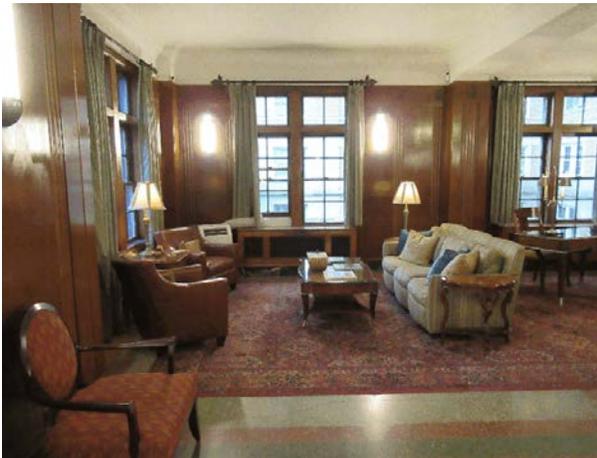
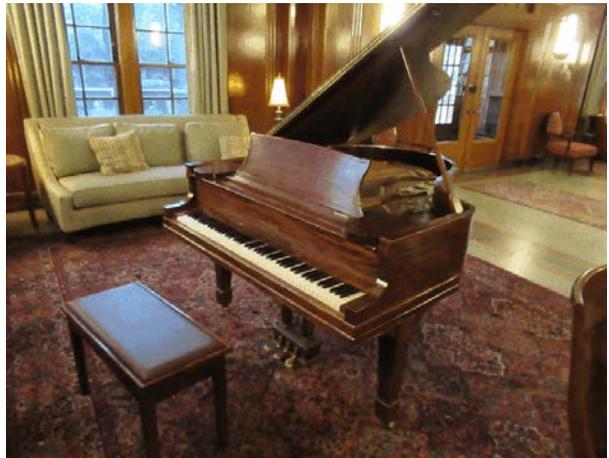
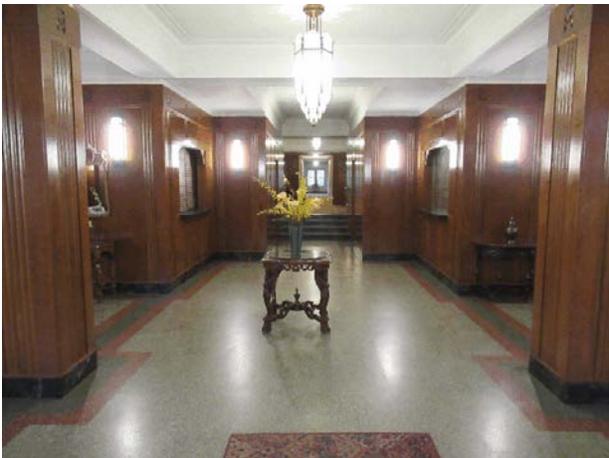
Condition: Good to fair overall with terrazzo floor cracks evident

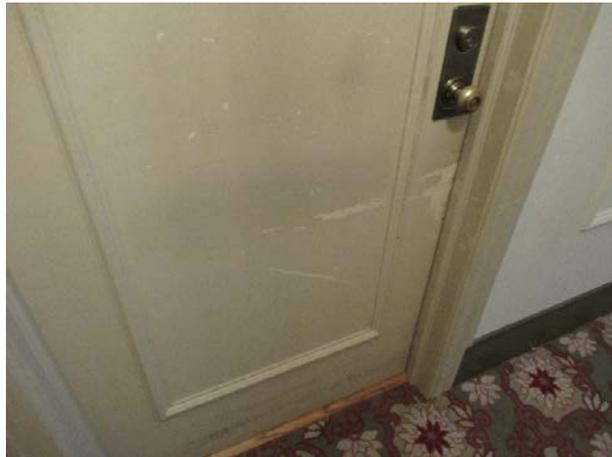
Significant scuffs at entry doors

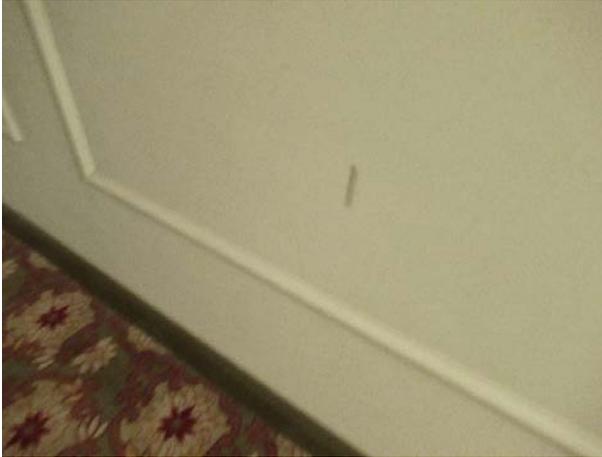
Wall scuffs

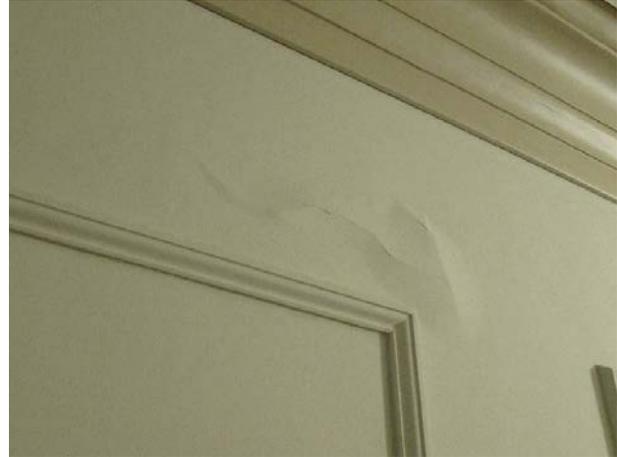
Paint peel

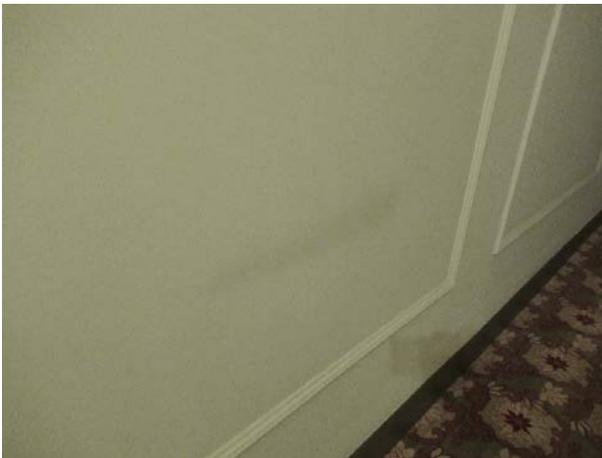
Wall scuffs

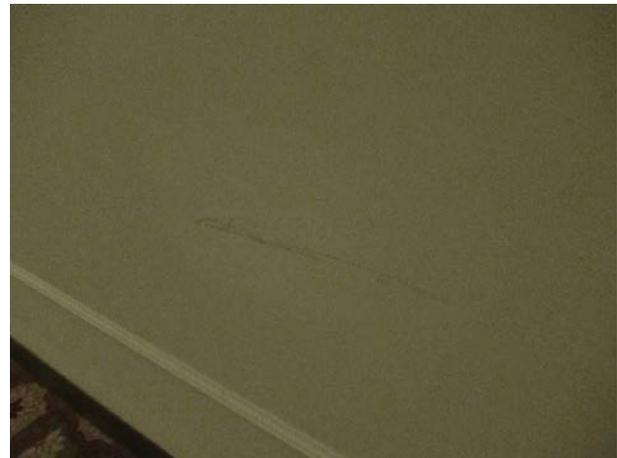
Wall scuffs

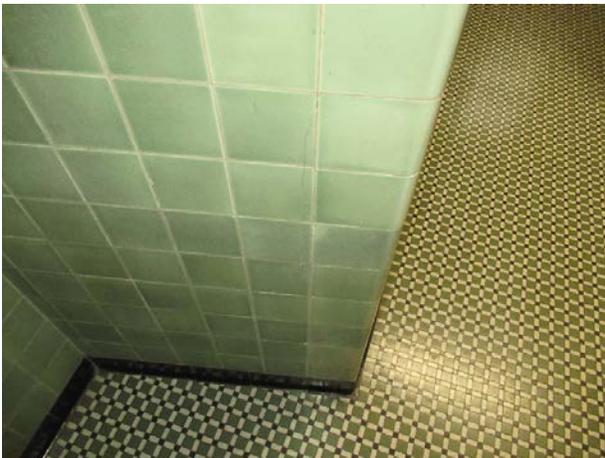
Condition: The rest rooms are in good to fair overall condition with tile cracks evident.

Tile crack

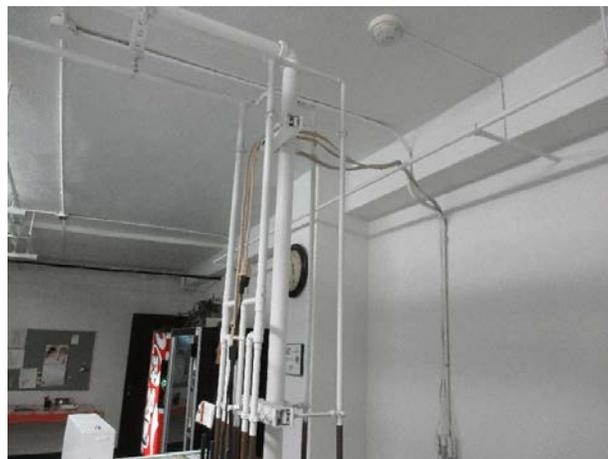
History: The Cooperative replaced much of the buildings electrical system in 2004. Management and the Board inform us the Cooperative added a breaker panel in 2019. Additionally, the two commercial units in the building are not metered separately from the building. The Cooperative would like to provide separate metering for these entities. In addition, five of the Association's laundry machines use extension cords ran externally to provide power from wall outlets. The Association would like to rewire these machines.

Electrical wiring for laundry machines uses extension cords run externally to wall outlets

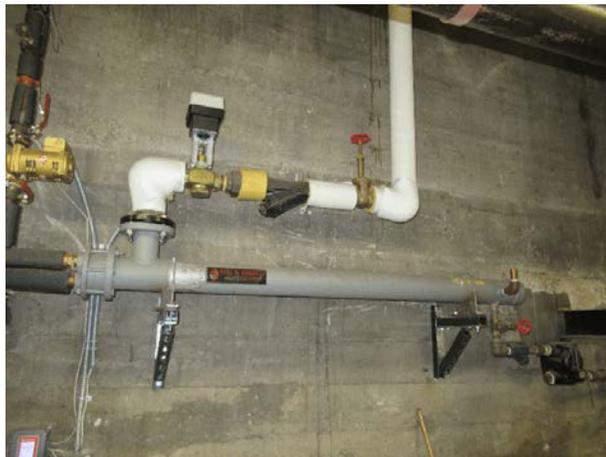
Heat exchanger

Condition: The heat exchanger is non-functional since 2018.

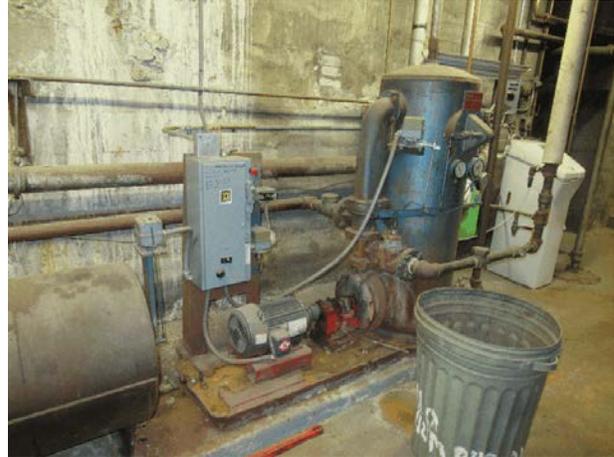
Condensate return system

- One condensate return pump - original to conversion, the system is reportedly failing and Management and the Board anticipates the need to spend \$40,000 for replacement. The Association performed repairs in 2020 that includes replacement of five small diameter valves.
- One boiler room sump pump - replaced in 2020, reported satisfactory
- Two garage sump pumps – installed in 2014, capacity is reported as insufficient to meet demand. The Cooperative plans to replace the pumps in 2020.

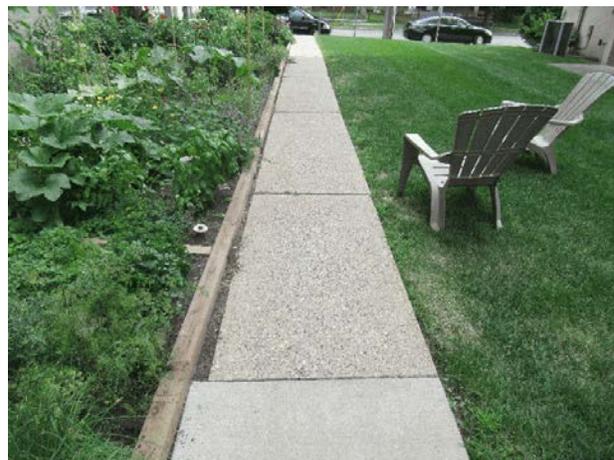
Sidewalk overview with surface pitting

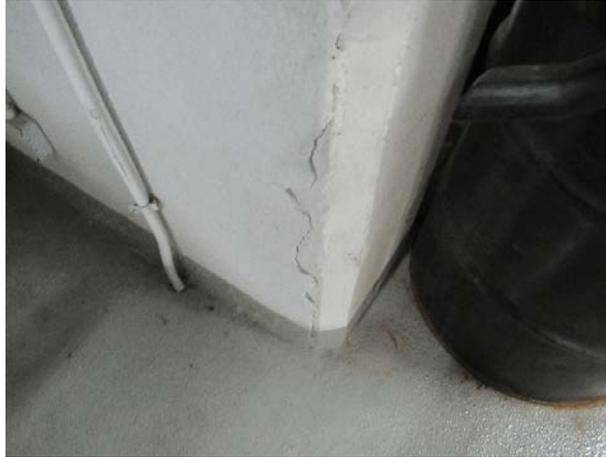
Condition and History: Good to fair overall with prior repairs and concrete deterioration evident. The elevated structural concrete does utilize a protective traffic coating.

Deterioration of wall concrete

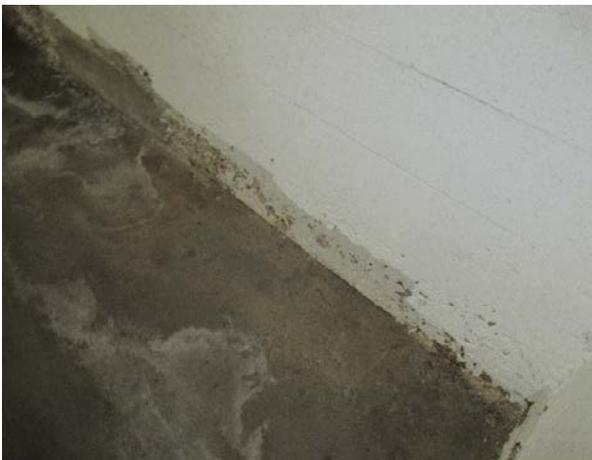
Condition: Fair overall with cracks, concrete deterioration, surface pitting and prior repairs evident. The Cooperative was in the process of adding a sealant to the perimeter walls and performing on-grade floor and column repairs at the time of our inspection.

Concrete deterioration at lower walls

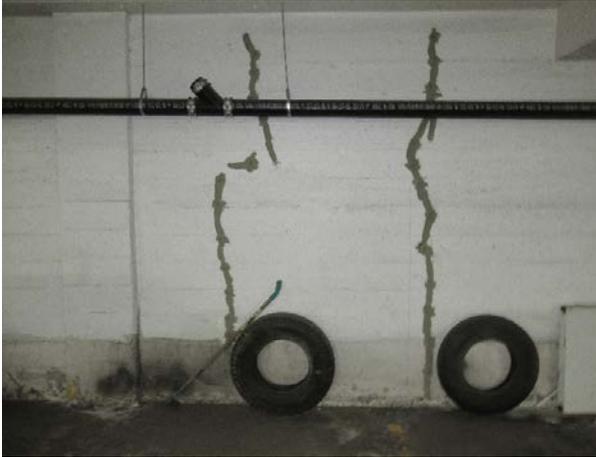
Prior wall crack repairs

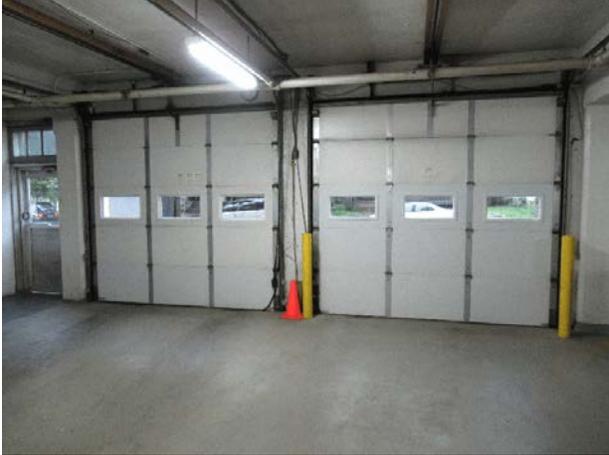
Condition: Reported satisfactory with minimal outages

Overview of garage doors

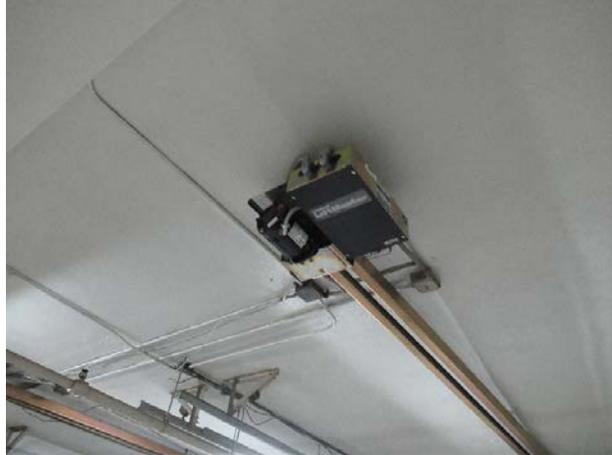
Overview of operators

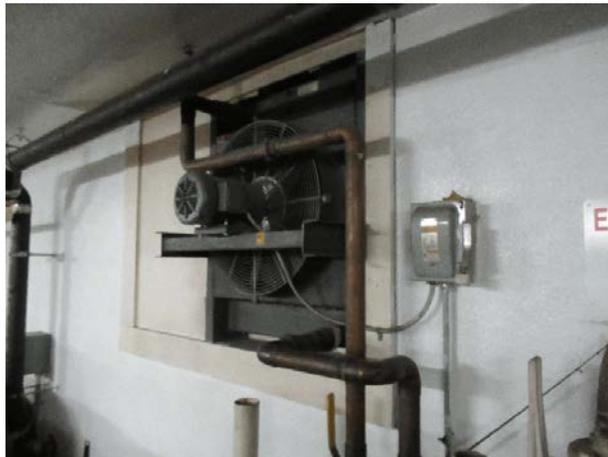
History: The Cooperative has proposals for replacement of the fans in 2020.

Wall exhaust fan

Expenditure Detail Notes: Expenditure timing and costs are depicted in the **Reserve Expenditures** table in Section 3. We regard interim repairs or partial replacements of components as normal maintenance. We include the estimated cost of \$9,000 for replacement of the fans.

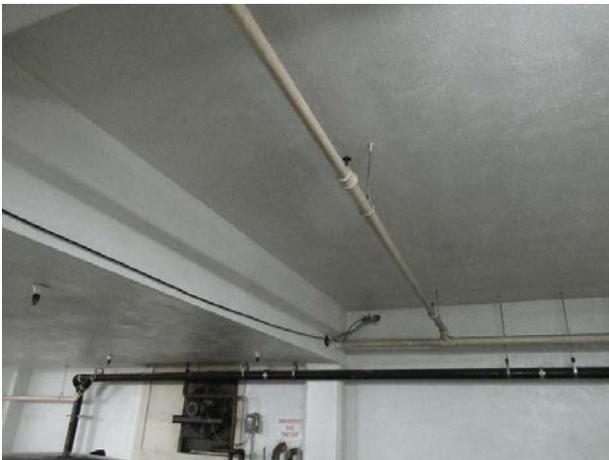
Condition: Reported satisfactory

Fire suppression system piping and sprinkler head

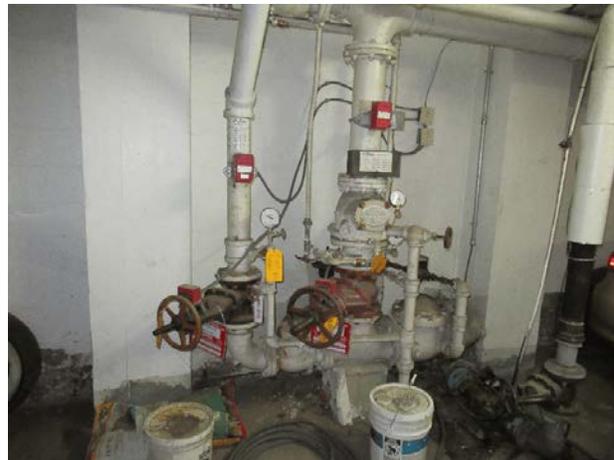
Fire suppression system inlet piping and valves

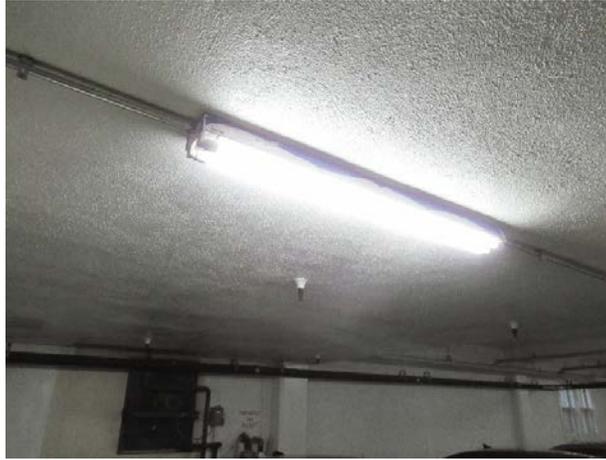
Condition: Reported satisfactory

Overview of light fixture

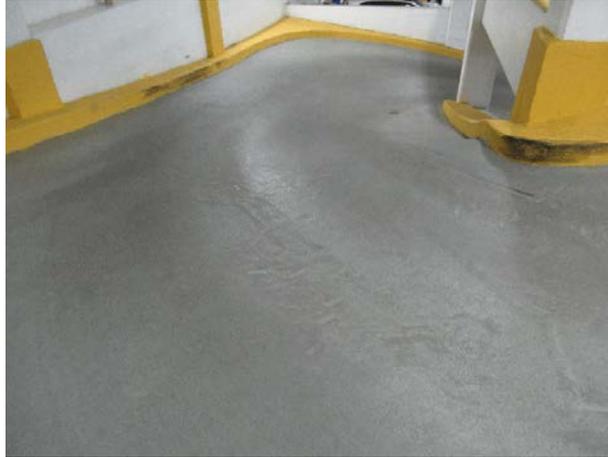
Condition: Good to fair overall with prior repairs evident

Traffic coating at ramp to on-grade parking

- Complete inspection of the garage concrete and concrete repairs as described in the previous narrative “**Concrete, Elevated Floors**”
- Preparation of the concrete surface
- Application of a urethane base coat, intermediate aggregate coating and top coat to the elevated floors
- Parking and directional line striping as needed

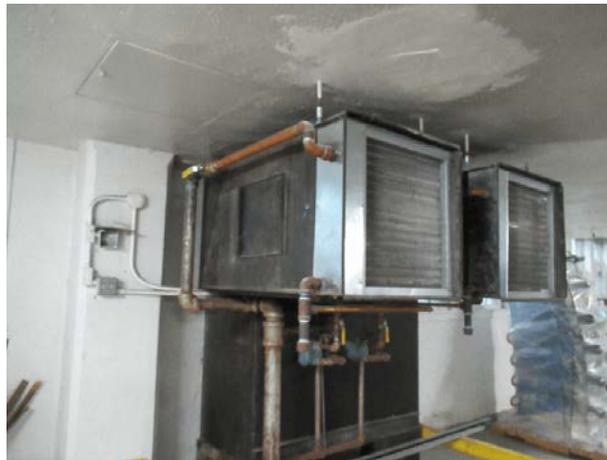
Condition: Reported satisfactory

Overview of unit heaters
